9817 Horace Harding Expressway
APT-30
Corona, NY 11368
(347) 755-4484
homeinspectionstoday.net
simon@homeinspectionstoday.net
Inspected By: Simon Perez

Residential Inspection Report

Inspected on Sun, Aug 12 2018 at 9:00 AM

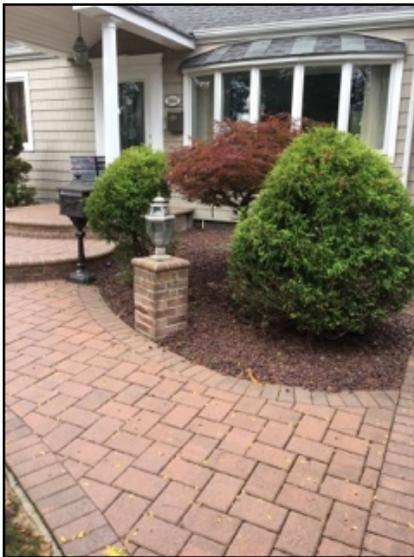
Figure 11-1

Shrub and tree growth are far enough away from the siding of the house except as noted below. Regular maintenance and pruning should be done on an ongoing basis to prevent contact in the future which could lead to wood rot and unwanted moisture contacting the siding of the house.

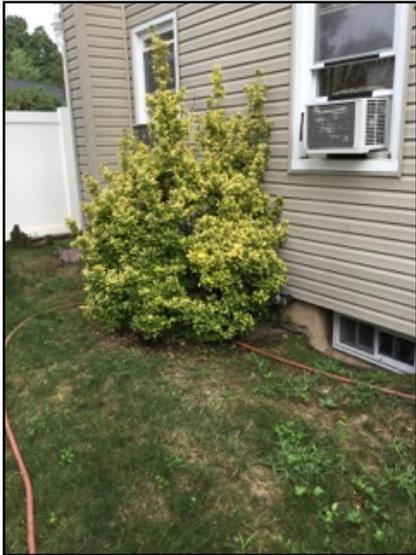
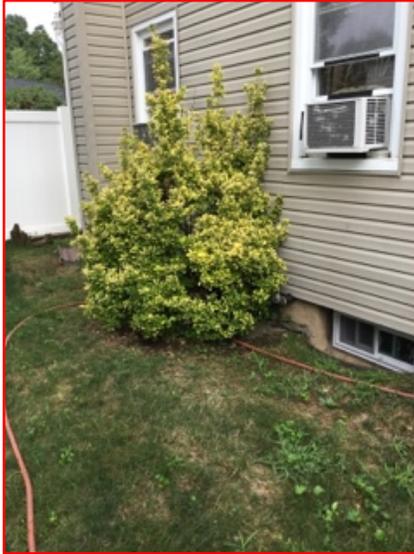
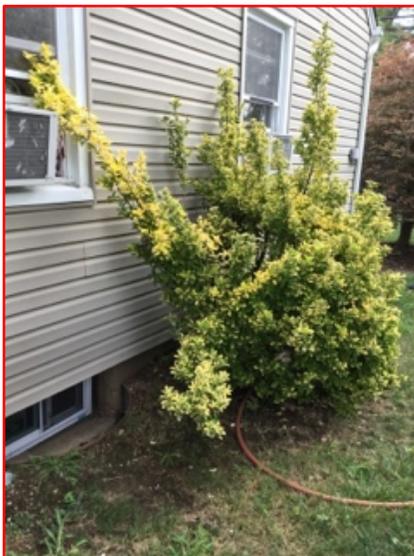
Figure 12-1

Comment 12:
Shrub and tree growth are against siding. Recommend Regular maintenance and pruning should done to prevent wood rot and unwanted moisture contacting the siding of the house.

1) Shrub and tree growth are against siding. Recommend Regular maintenance and pruning should done to prevent wood rot and unwanted moisture contacting the siding of the house.

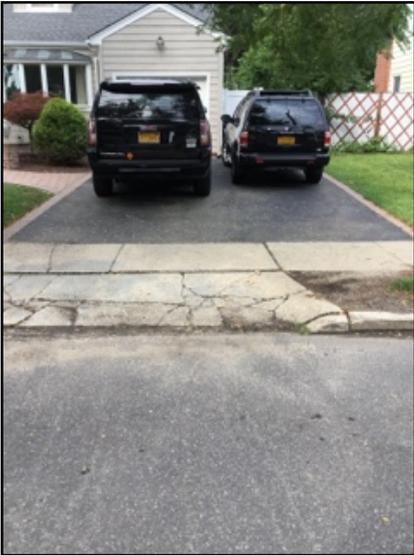
Figure 13-1

Comment 13:
The asphalt driveway was in good condition with minor cracks. Recommend regular sealcoating every 2-3 years to preserve the driveway and keep it from cracking and deteriorating. Underground tree roots, salt, snow melting products and lack of maintenance are the biggest contributors to asphalt deterioration.

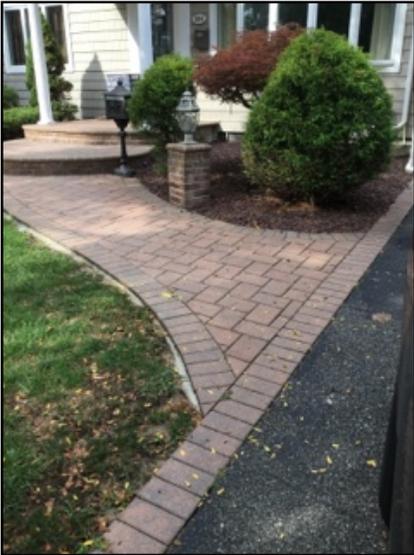
Figure 14-1

The front walkway is in good condition with no major defects noted. Salt and snow melting products are the biggest contributors to surface deterioration. Regular maintenance is required to keep the walkway from deteriorating and cracking.

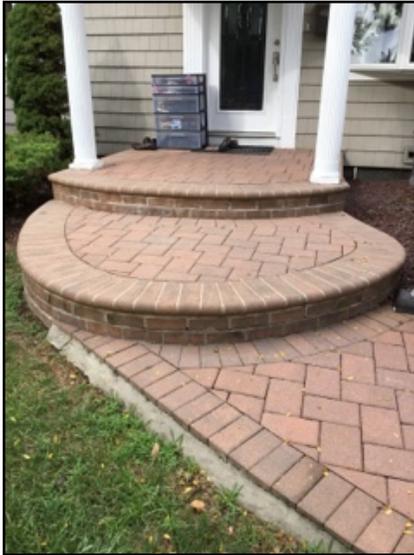
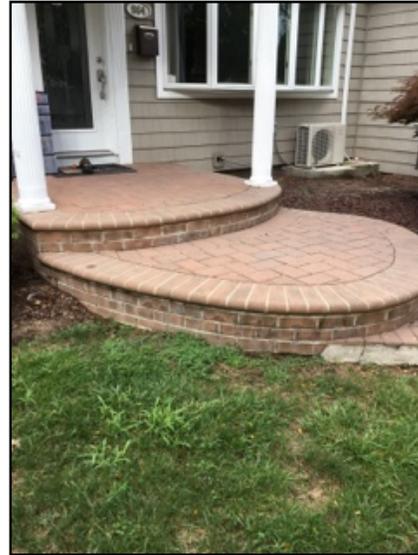
The front steps are in good condition with no major defects. Salt and snow melting materials are the largest contributor to surface deterioration.

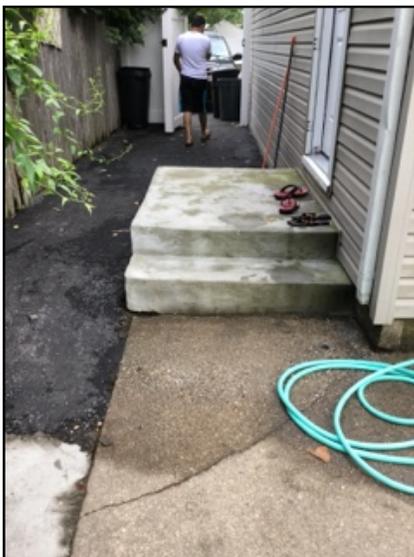
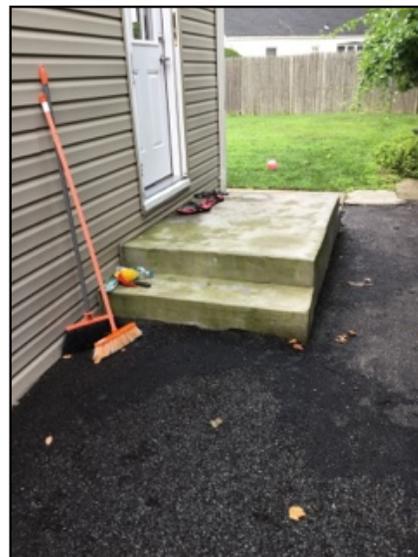
The side steps are in good condition with no major defects. Salt and snow melting materials are the largest contributor to surface deterioration.

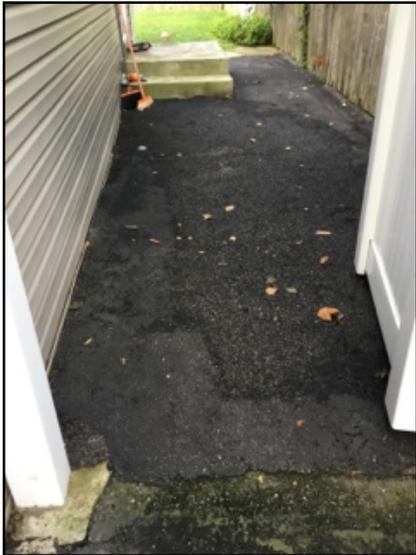
Figure 17-1

The side walkway is an asphalt walkway and in good condition with no major defects noted. Salt and snow melting products are the biggest contributors to surface deterioration. Regular maintenance is required to keep the walkway from deteriorating and cracking.

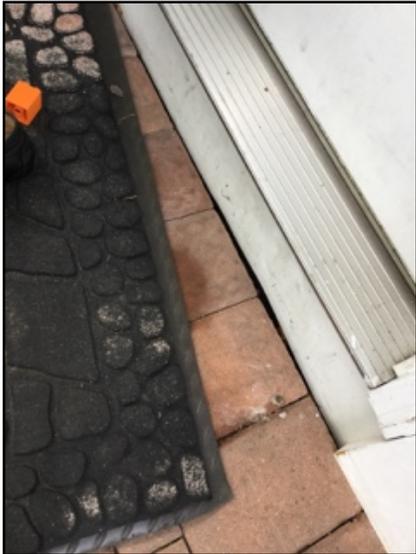
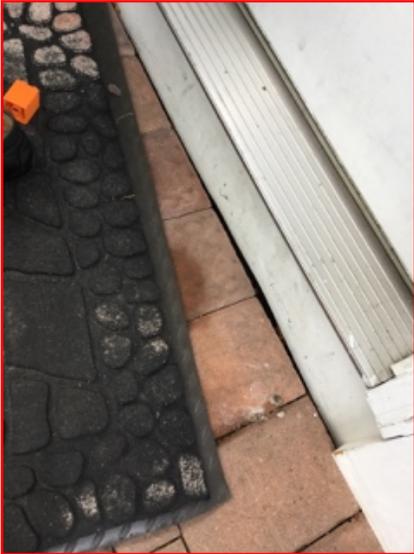
Figure 18-1

Comment 18:
There is a gap between the front steps and door. Recommend closing to prevent any water intrusion.

2) There is a gab between the front steps and door. Recommend closing to prevent any water intrusion.

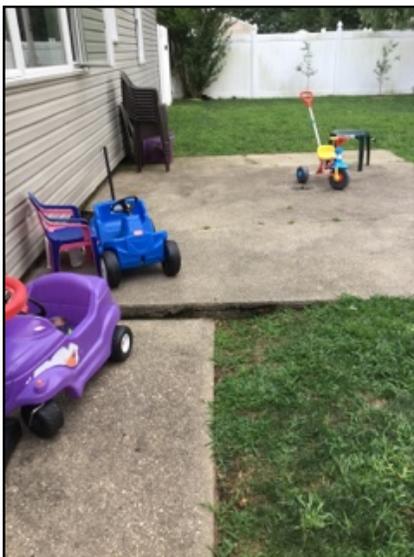
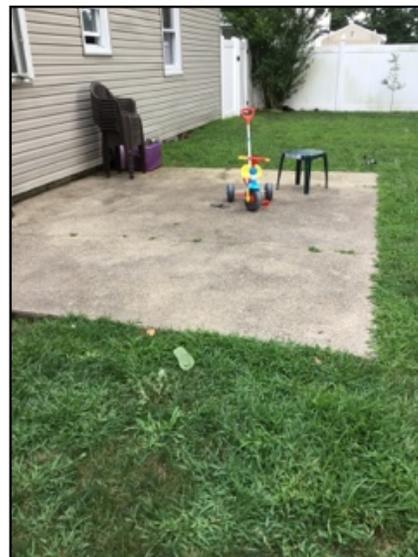
The patio is in good condition with no major defects or cracks noted. Salt and snow melting products are the biggest contributors to surface deterioration. Any cracks should be immediately sealed to prevent further deterioration and spreading. Regular cleaning and maintenance is recommended to keep the patio free of dirt and moss build-up, especially between any of the joints.

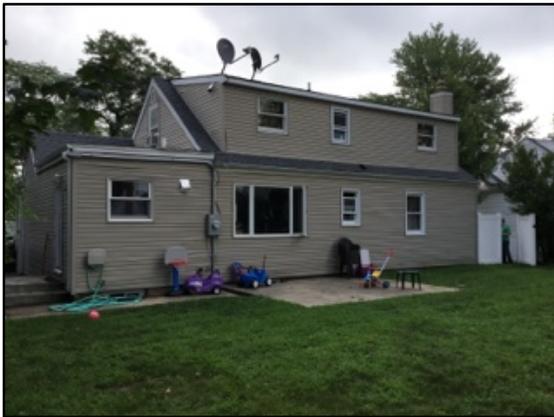
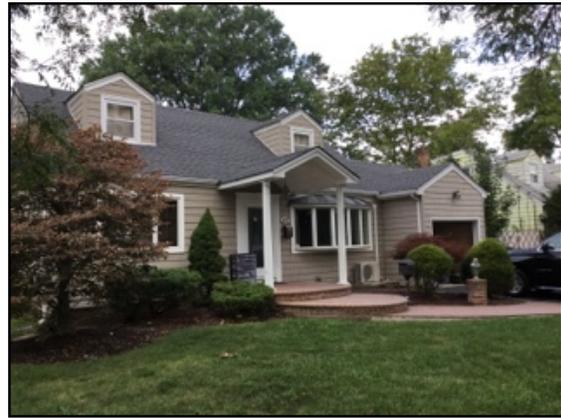
The exterior siding of the house is maintenance free vinyl and in good condition with no defects noted. Recommend regular cleaning and power washing to keep the siding in good condition.

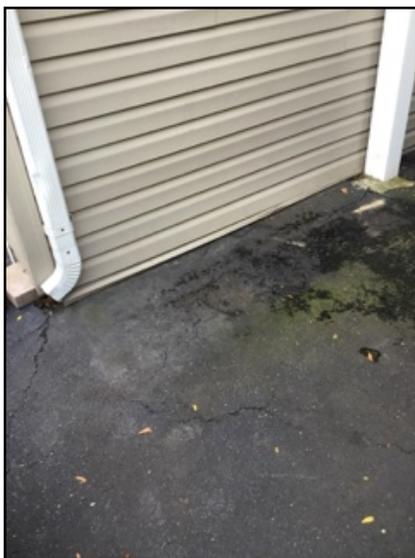
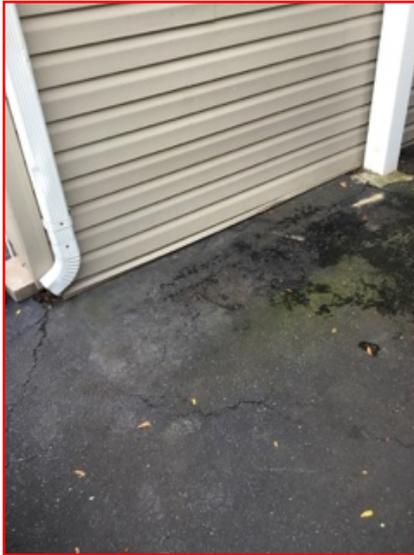
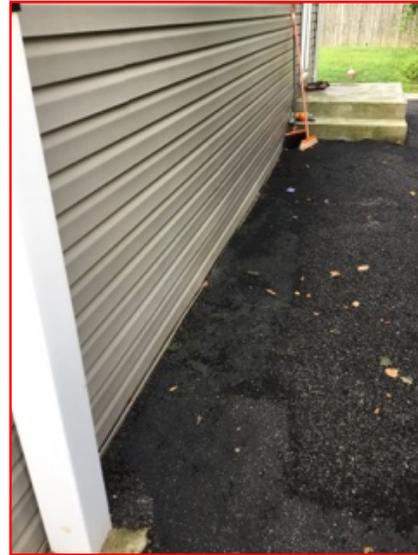
Figure 21-1

Vinyl siding is not high enough of the asphalt walkway. Recommended repairing as necessary to prevent any future damages.

3) Vinyl siding is not high enough of the asphalt walkway. Recommended repairing as necessary to prevent any future damages.

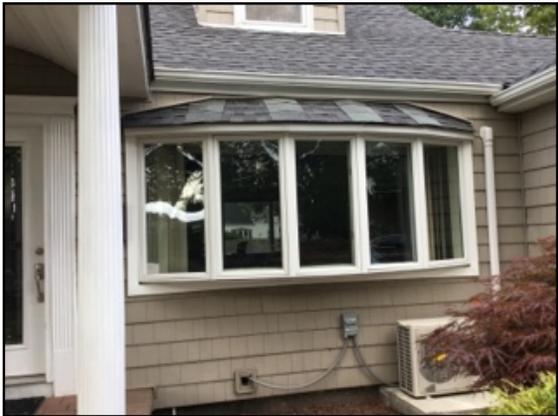
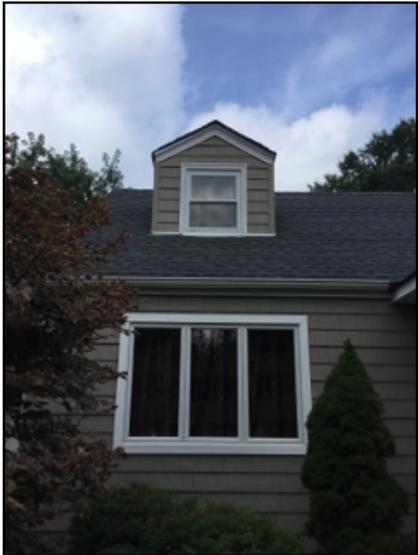
The windows are all maintenance-free wood/vinyl windows. No major defects were noted on the exterior on the day of inspection. The exterior of the windows were all wrapped in maintenance-free aluminum and in good condition.

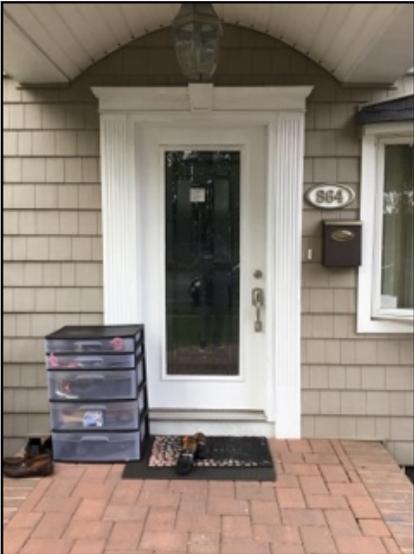
Figure 23-1

Comment 23:
The front door is in good condition with no defects noted. Although not a defect, there was no combination screen and storm door and it is recommended to install one for energy efficiency purposes.

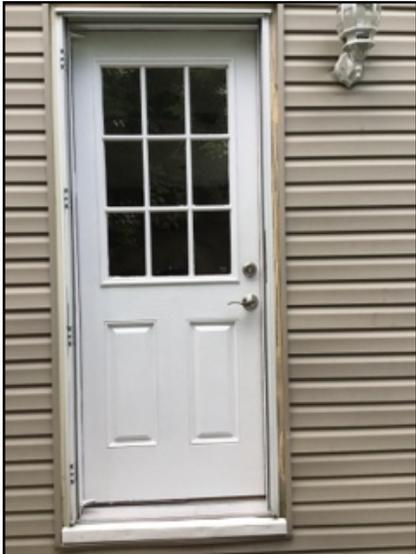
Figure 24-1

Comment 24:
The side door is in good condition with no defects noted. Although not a defect, there was no combination screen and storm door and it is recommended to install one for energy efficiency purposes.

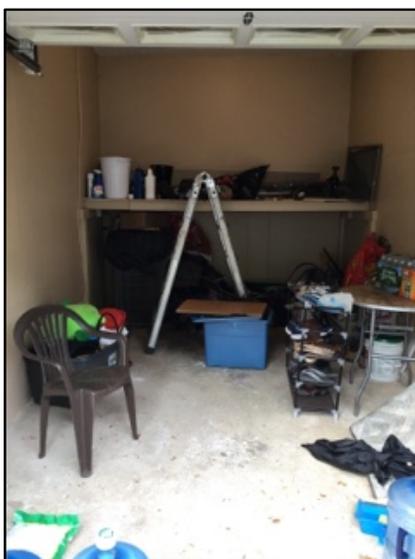
Figure 25-1

The 1 car attached garage is in good condition with no defects noted. The garage door is manually operated. The garage was fully sheet rocked for fire safety purposes.

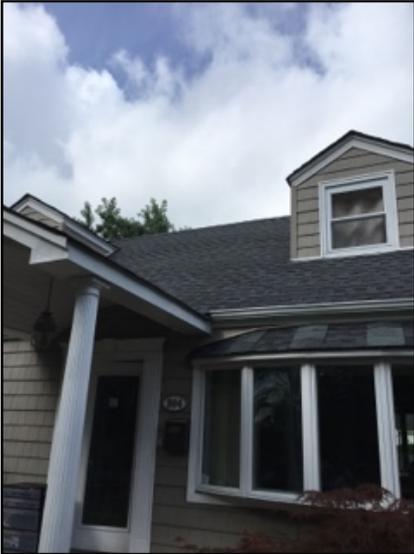
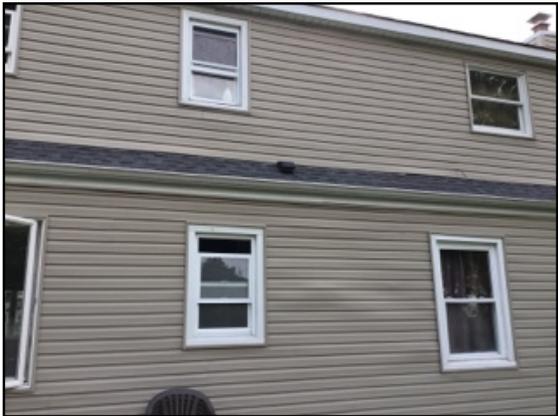
The roof is comprised of architectural shingles and is approximately 2 years old. These type shingles are rated for a 30-100 year life expectancy depending on weather conditions, climate and other factors. Venting was proper with gable, ridge and soffit vents, and the plumbing stacks were noted and at an adequate height above the roof line.

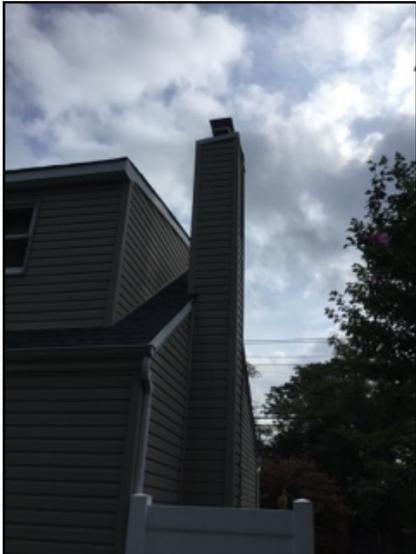
Figure 27-1

The chimney is in good condition with no major cracking in the mortar joints and flashed correctly to the roof. There is a proper spark arrestor and rain cap on the top of the chimney and no major defects were noted.

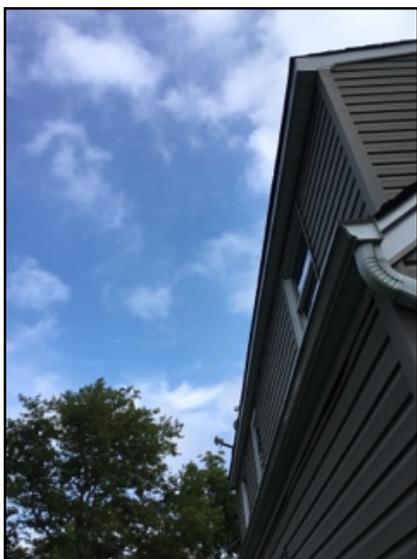
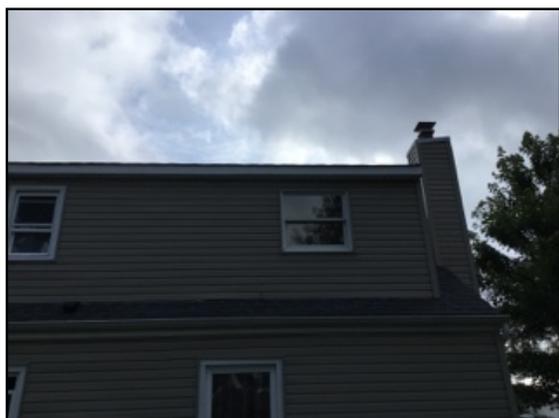
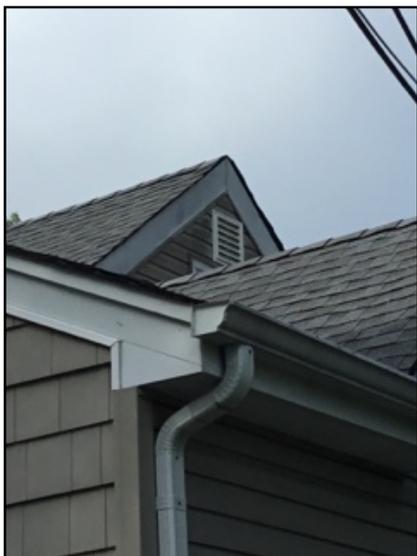
The fascias and soffits are comprised of maintenance-free vinyl and aluminum and are in adequate condition. It is important to immediately repair any soffit or fascia materials that may become loose or dislodged to prevent water and ice from getting behind these surfaces and causing damage to any wood products.

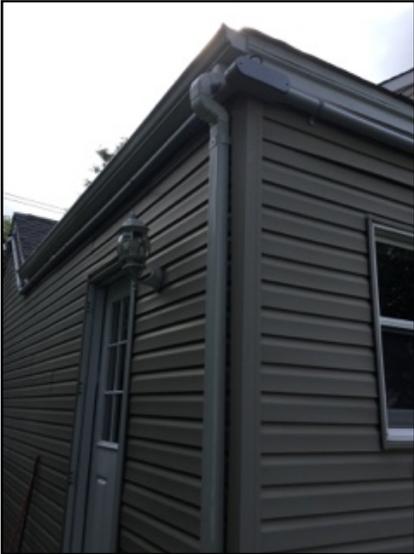
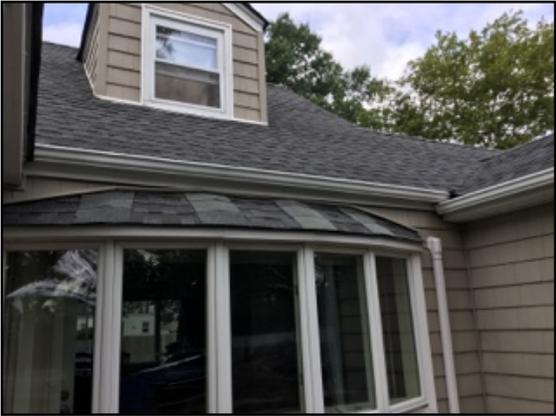
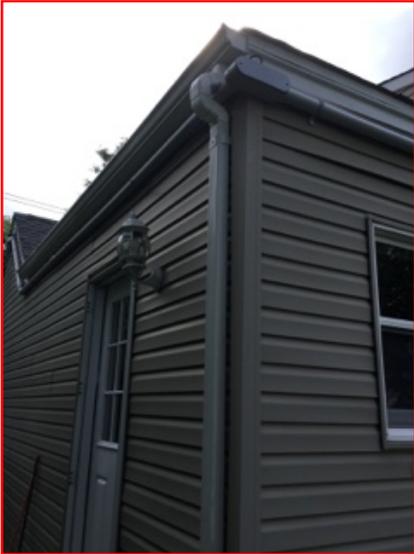
The gutters are aluminum and do not have proper extensions to divert rain water from the building. It appears that the gutters are functioning properly but the downspouts are not far enough away from the foundation and there are signs of moisture pooling against foundation. Recommend keeping gutters free and clear of debris as well as adding extensions to downspouts to prevent future damage to foundation.

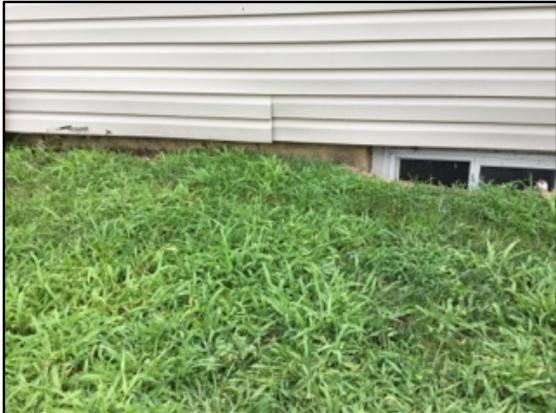
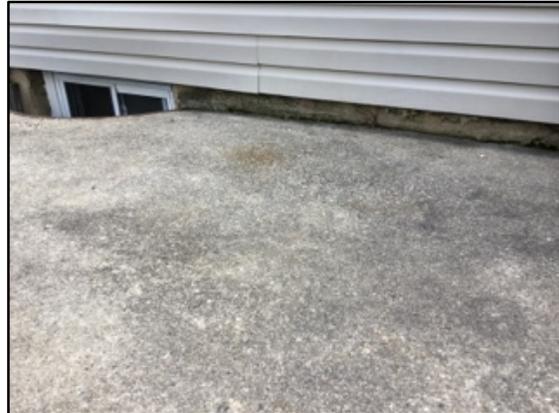
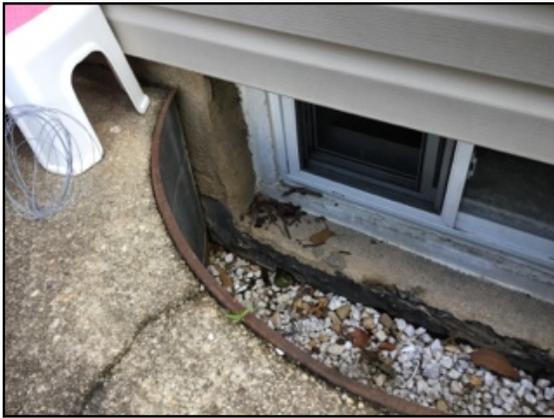
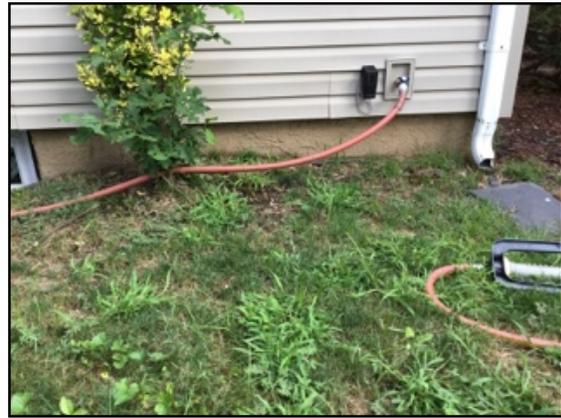
The foundation walls are poured concrete and in good condition on the exterior. There were no major cracks or defects noted on the exterior blocks of the foundation on the day of inspection.

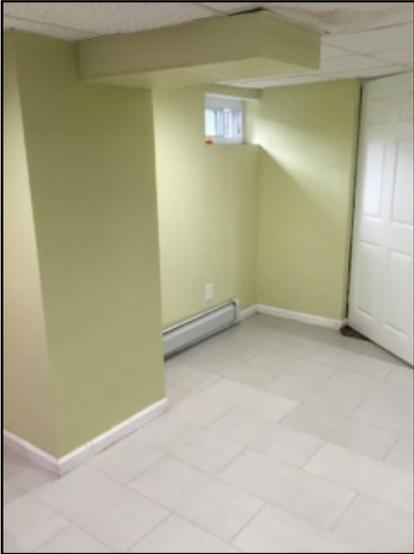
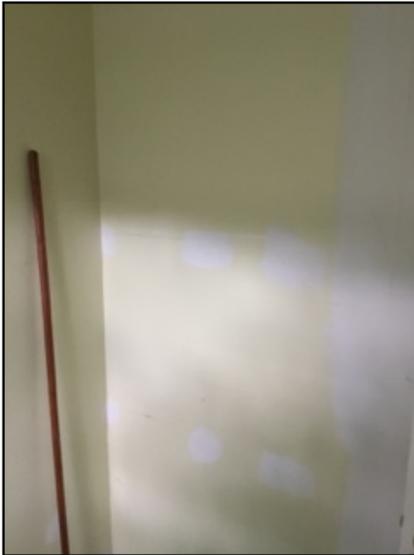
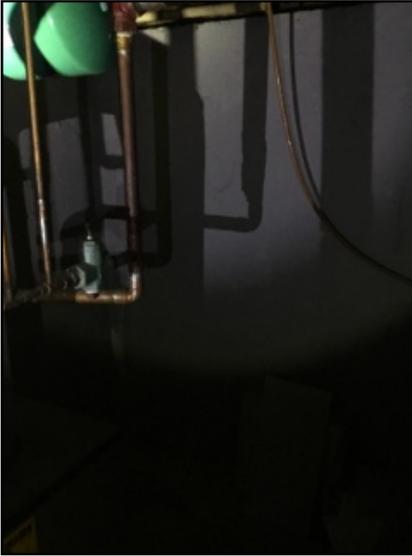
The interior of the basement appears to be in good condition as there are no active water marks or stains and the moisture content in the foundation walls are low as measured with a moisture meter. The framing and support of the house as seen from the basement are in good condition (limited visibility due to the basement being mostly finished) and to traditional building methods. No major defects were noted on the interior on the day of inspection.

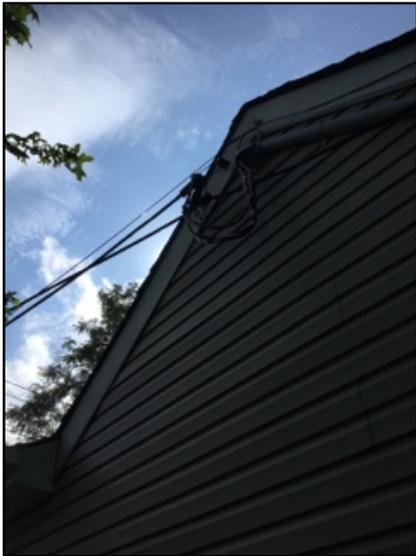
Figure 32-1

The electrical service is overhead and to a meter on the side of the house. The electric panel was located in the basement and is 200 amp main service. The panel was in good condition with no defects noted and grounding was proper. There were no double taps or missing covers and there was additional room for expansion.

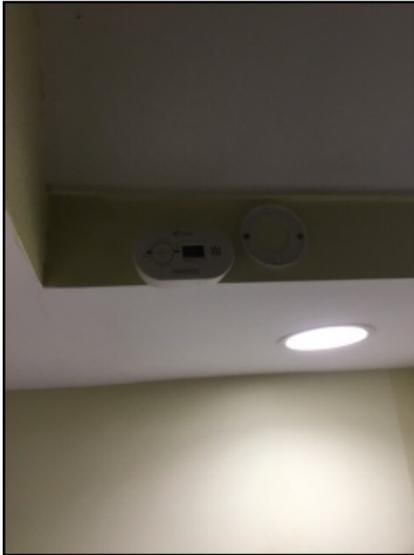
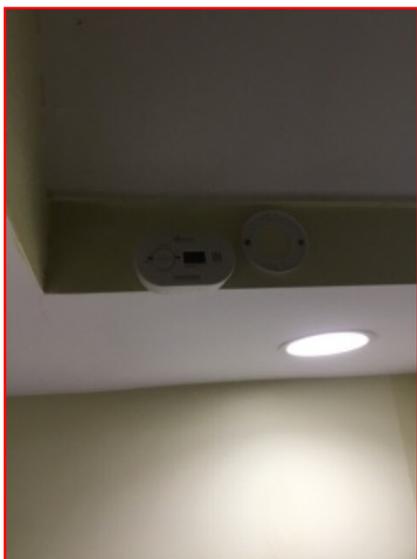
Figure 33-1

Smoke and carbon monoxide detectors are important safety devices designed to save lives. It is always recommended to install new detectors when moving into a home if they are 9 volt battery operated (not hard wired systems).

5) Smoke and carbon monoxide detectors are important safety devices designed to save lives. It is always recommended to install new detectors when moving into a home if they are 9 volt battery operated (not hard wired systems).

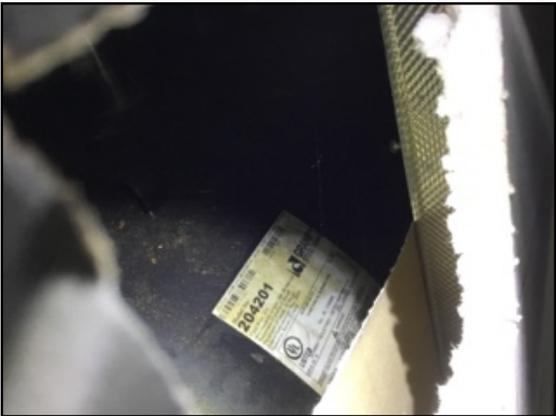
Figure 34-1

The boiler and hot water heater are combined and it's a Peerless Boiler oil fired unit and approximately 13 years old and in working condition. The unit appears to have been well maintained and serviced properly throughout the years as evidenced by the service tags. It is recommended to get annual servicing of the unit to keep it at peak operating efficiency.

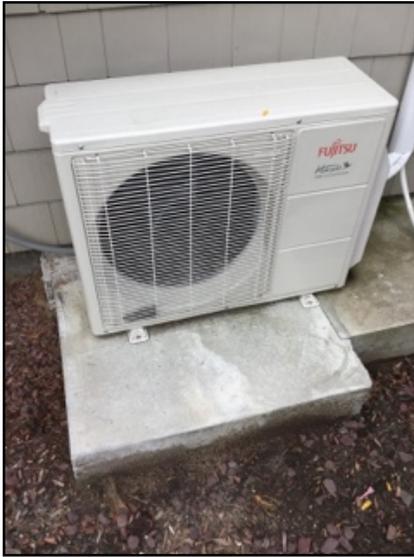
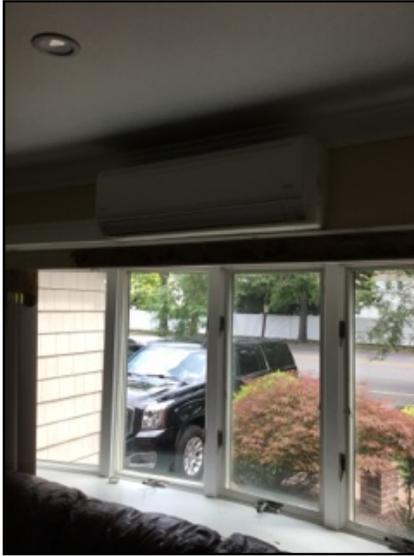
The air conditioning system was tested and operated properly on the date of inspection. No major defects were noted and it is recommended to have proper servicing done annually to ensure maximum efficiency. The refrigerant lines and electrical disconnects were noted and in good condition.

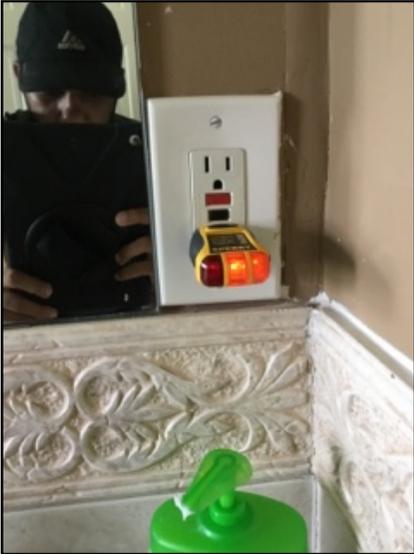
Figure 37-1

The main bath was in working condition with no leaks noted at the sink, toilet or tub/shower. There was a window and exhaust fan for ventilation and no mold or mildew was noted on the walls or ceiling.

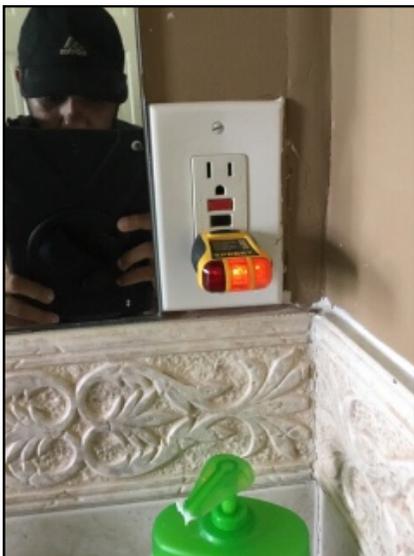
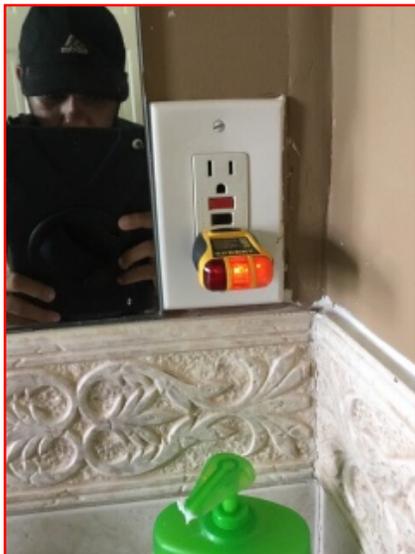
Figure 38-1

The outlet in the bathroom is a GFCI outlet and it did not operate properly the day of inspection. Recommend hiring a licensed electrician to replace the outlet with a GFCI outlet as necessary.

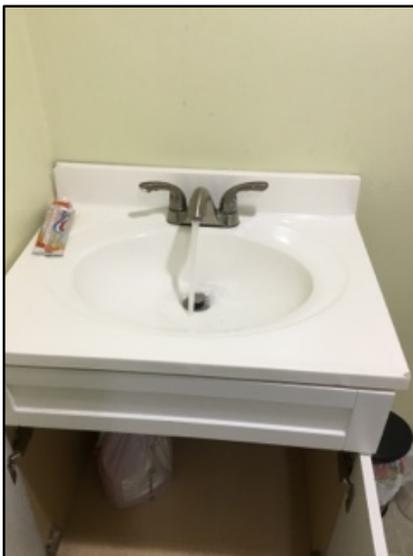
Figure 39-1

The 1/2 bath was in working condition with no leaks noted at the sink or toilet. There was an exhaust fan for ventilation and no excess moisture or mold was noted. The GFCI was tested and operated properly.

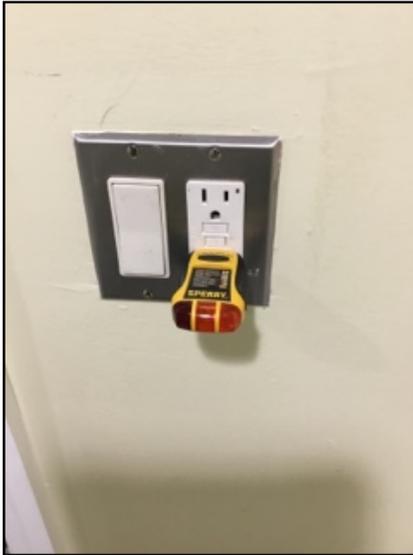
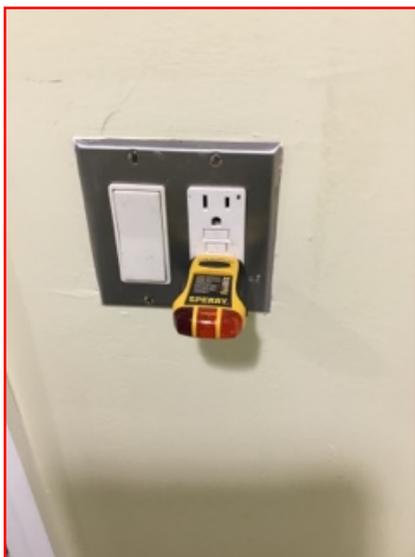
Figure 40-1

The outlet in the bathroom is a GFCI outlet but is not working or tripping with my test equipment and is a safety hazard. Recommend hiring a licensed electrician to replace the existing outlet with a working GFCI outlet as necessary.

7) The outlet in the bathroom is a GFCI outlet but is not working or tripping with my test equipment and is a safety hazard. Recommend hiring a licensed electrician to replace the existing outlet with a working GFCI outlet as necessary.

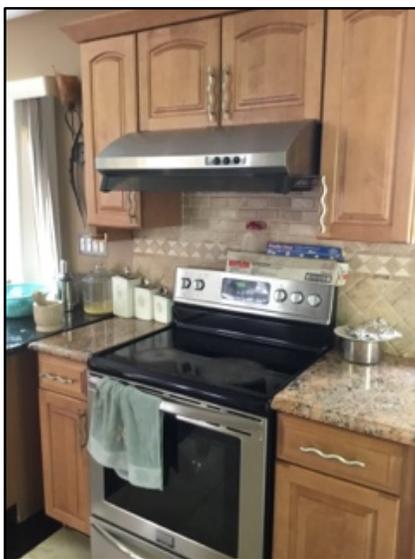
Figure 41-1

The kitchen was in working condition with no major defects noted. There were no leaks at the sink or dishwasher, and all the appliances were tested and operated properly on the date of inspection. All the cabinets and countertops were operational and secure. The exhaust fan over the stove (range hood exhaust) were tested and operated properly on the date of inspection.

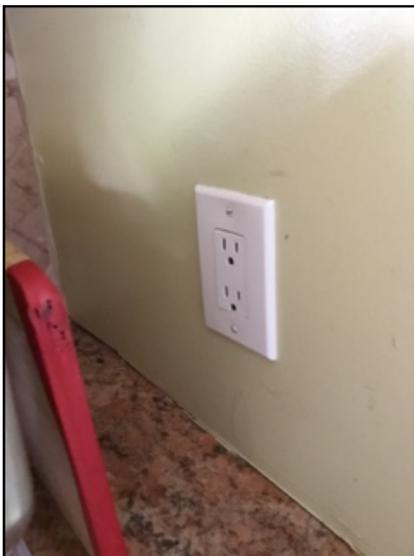
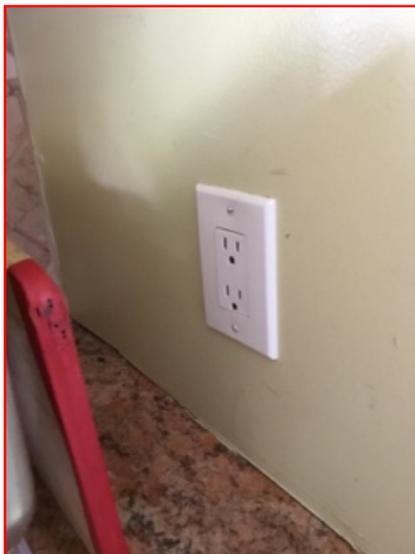
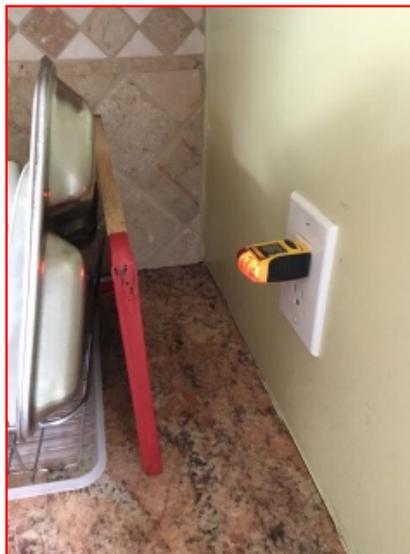
Figure 42-1

The outlets in the kitchen sink area are not GFCI and this is a safety hazard. Recommend hiring a licensed electrician to replace all outlets within 6' of the sink with GFCI outlets.

8) The outlets in the kitchen sink area are not GFCI and this is a safety hazard. Recommend hiring a licensed electrician to replace all outlets within 6' of the sink with GFCI outlets.

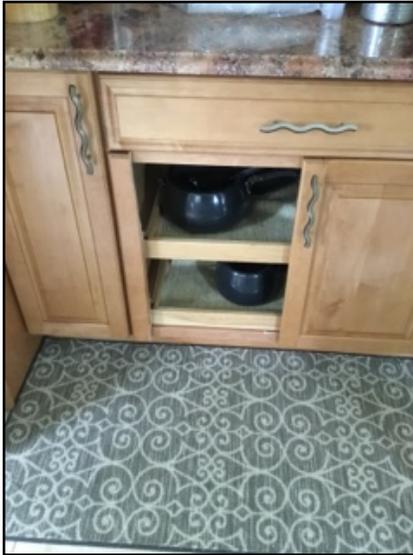
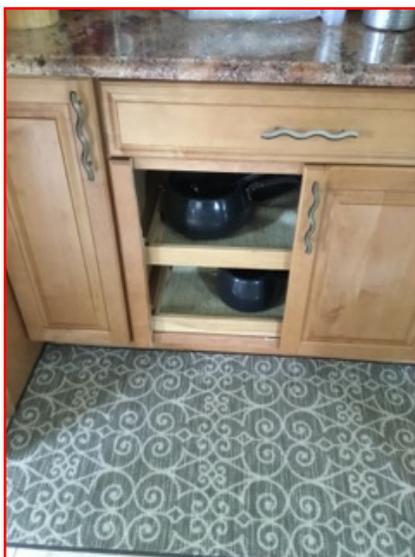
Figure 43-1

Cabinet door in the kitchen was broken and missing. Recommend replacing with new door.

9) Cabinet door in the kitchen was broken and missing. Recommend replacing with new door.

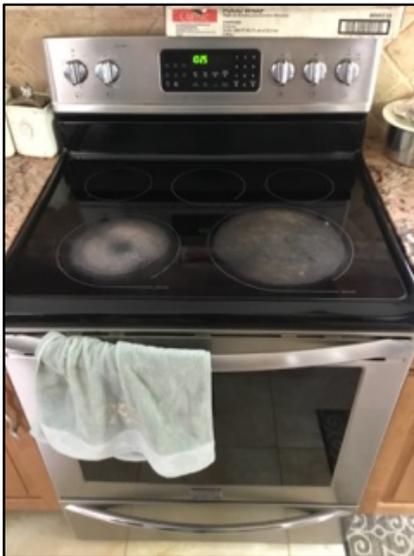
Figure 45-1

All the appliances were tested and were in working condition and the sink is a single unit in good condition with no leaks noted on the day of inspection.

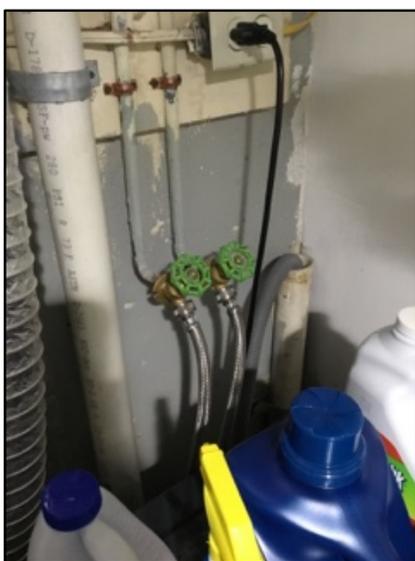
Figure 46-1

The laundry area was in acceptable condition with no major defects noted. There were no leaks at the washing machine connections.

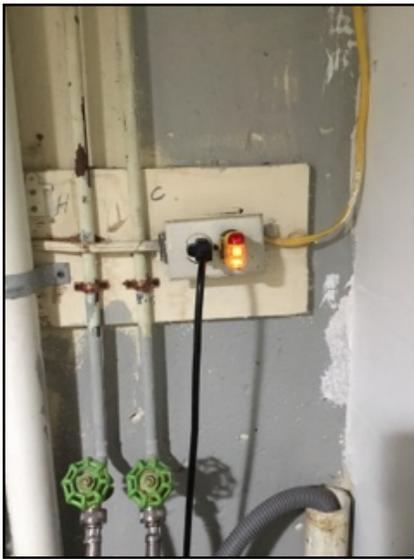
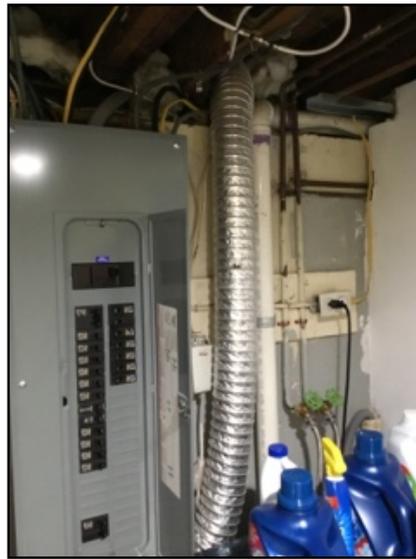
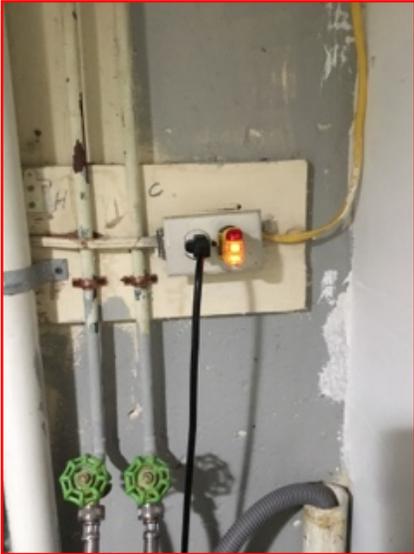
The outlet in the laundry area was not a GFCI outlet and is a safety hazard as it is directly below/next to the water supply lines. Recommend hiring a licensed electrician to replace the existing outlet with a GFCI outlet as necessary. The exhaust hose for the dryer is not connected to the dryer. The hose is also a ribbed hose you would want it to be solid metal. This is a huge fire and safety hazard. Recommend hiring a qualified contractor to install a dryer vent and to the exterior.

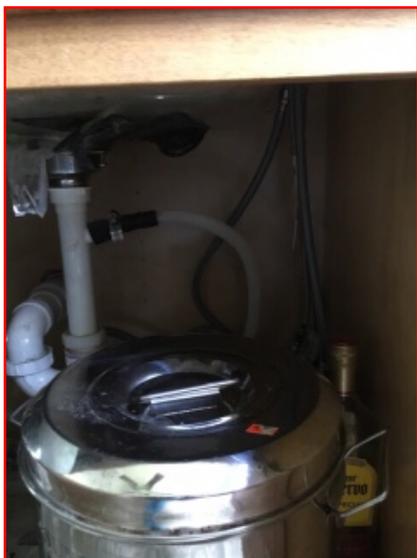
Figure 44-1

10) The dishwasher did not perform a loop to create a trap under sink.
