9817 Horace Harding Expressway
APT-30
Corona, NY 11368
(347) 755-4484
homeinspectionstoday.net
simon@homeinspectionstoday.net
Inspected By: Simon Perez

Residential Inspection Report

Inspected on Sun, Aug 12 2018 at 9:00 AM

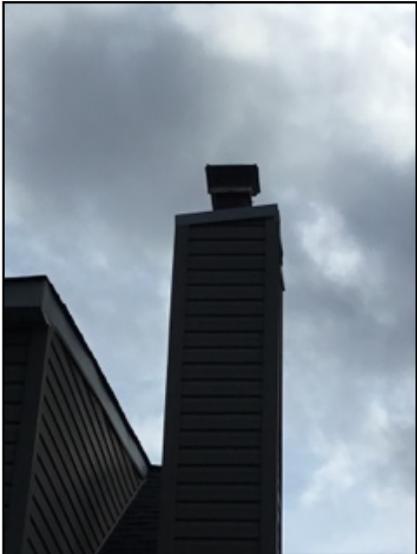
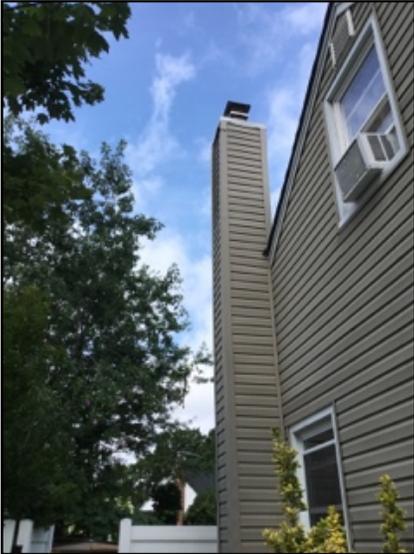
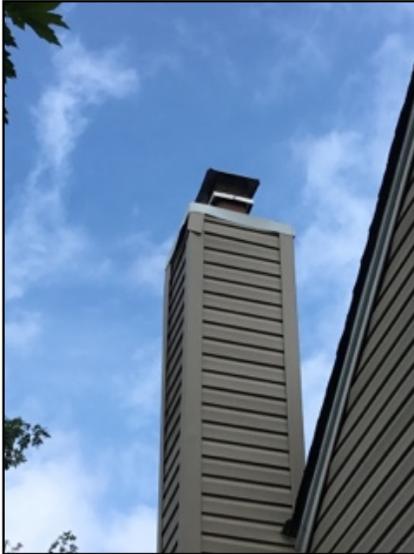
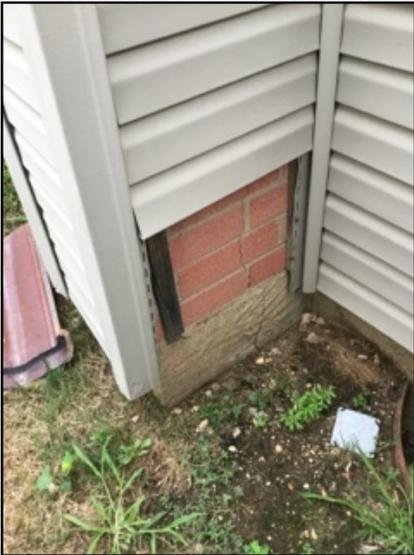
The chimney is in good condition with no major cracking in the mortar joints and flashed correctly to the roof. There is a proper spark arrestor and rain cap on the top of the chimney and no major defects were noted.

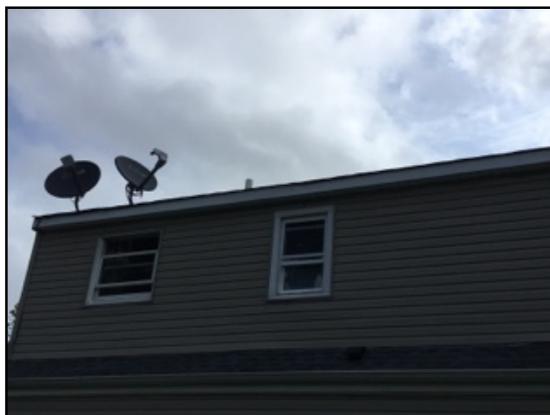
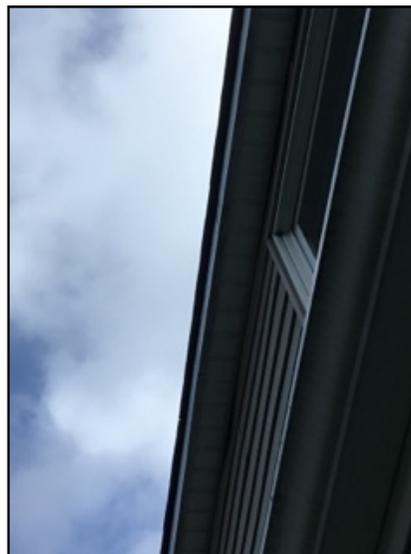
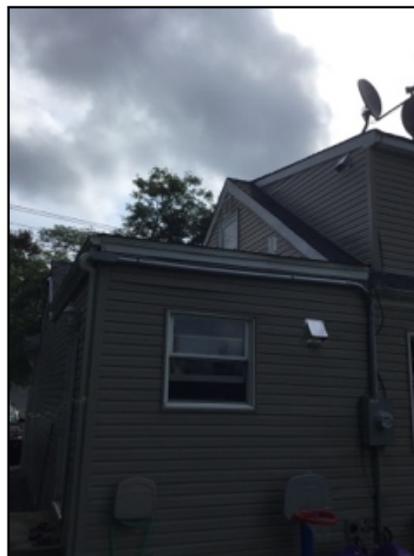
The fascias and soffits are comprised of maintenance-free vinyl and aluminum and are in adequate condition. It is important to immediately repair any soffit or fascia materials that may become loose or dislodged to prevent water and ice from getting behind these surfaces and causing damage to any wood products.

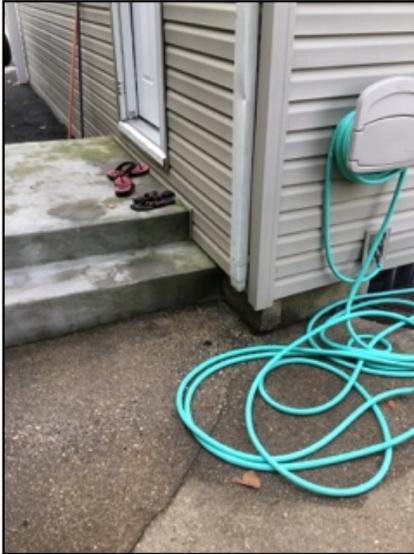
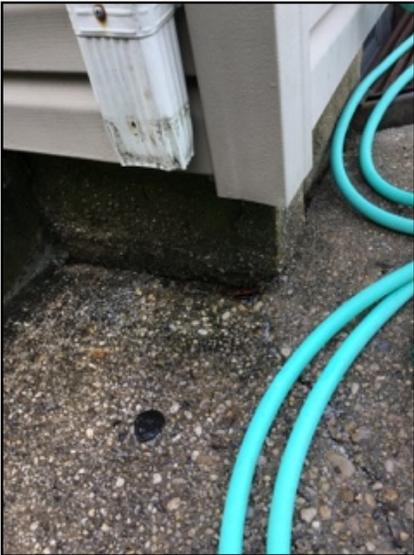
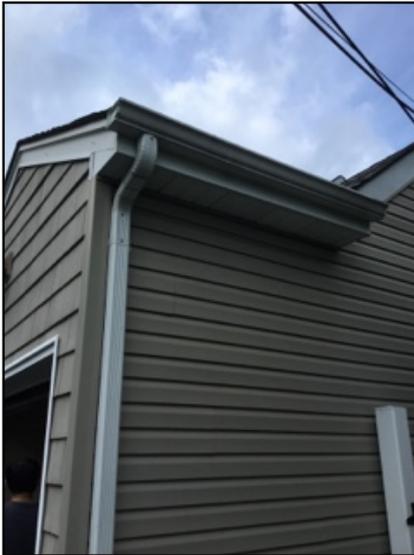
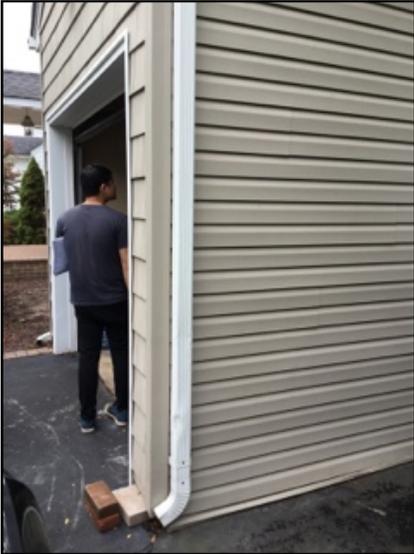
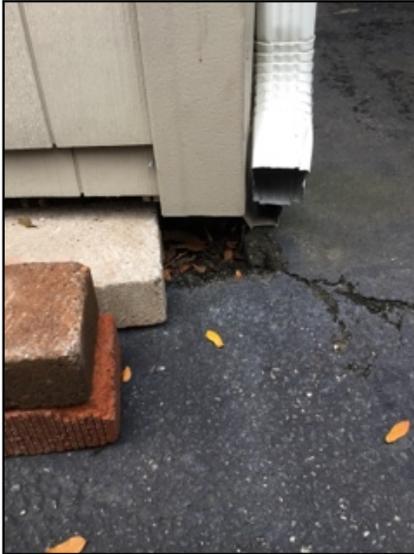
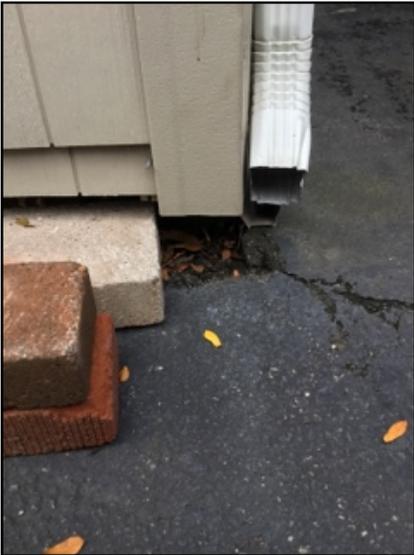
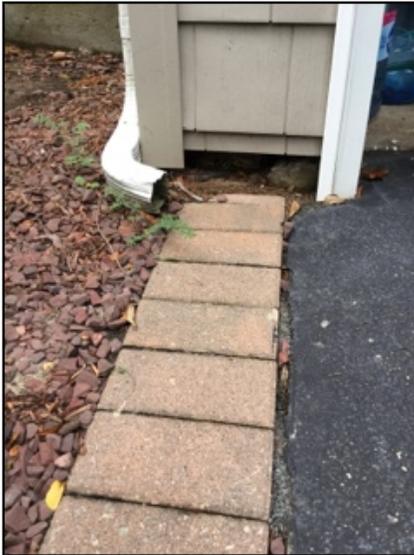
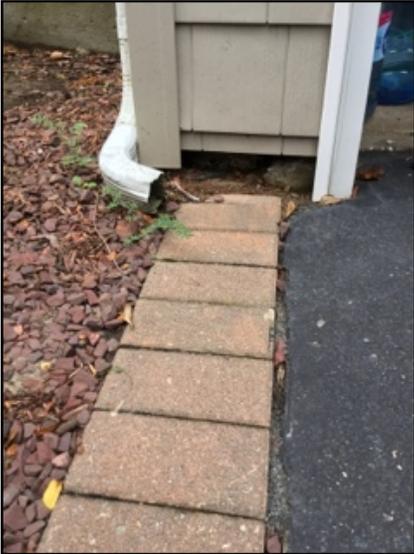
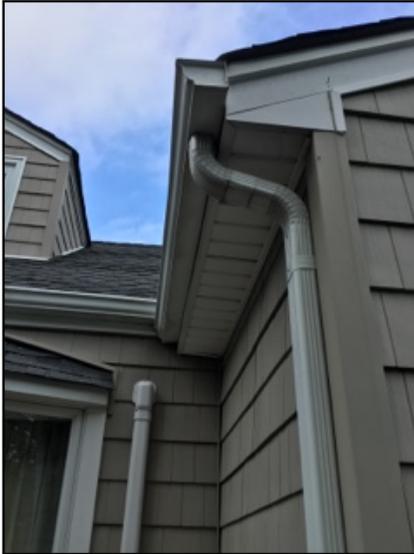
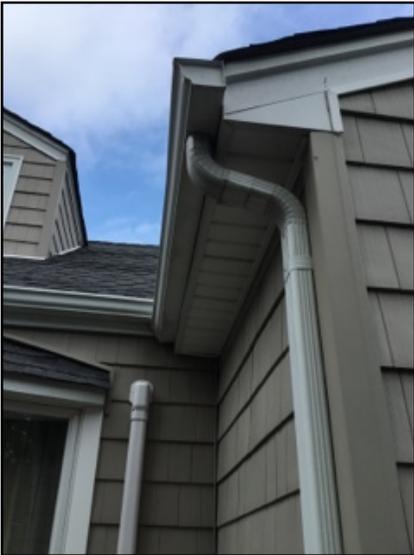
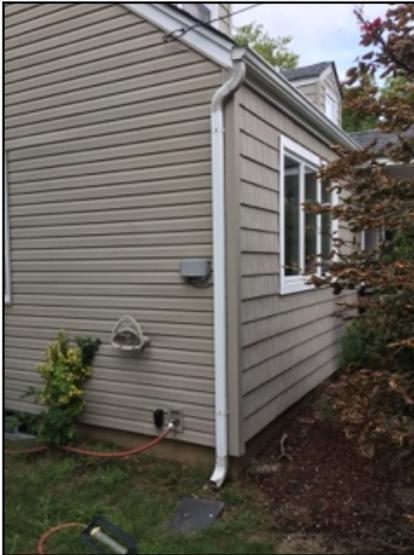
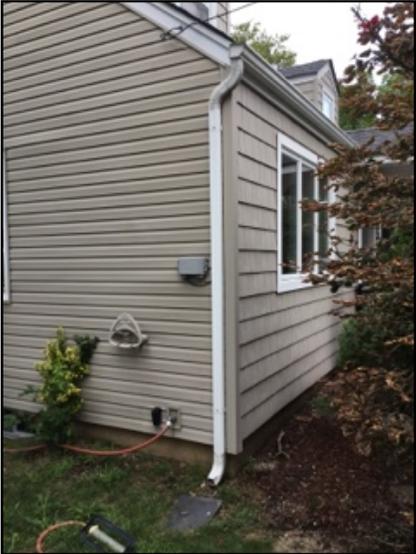
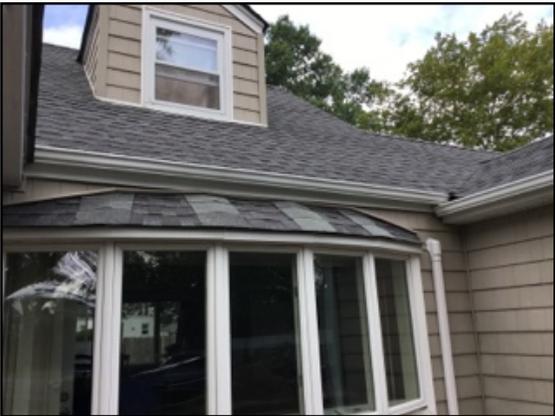
The gutters are aluminum and do not have proper extensions to divert rain water from the building. It appears that the gutters are functioning properly but the downspouts are not far enough away from the foundation and there are signs of moisture pooling against foundation. Recommend keeping gutters free and clear of debris as well as adding extensions to downspouts to prevent future damage to foundation.

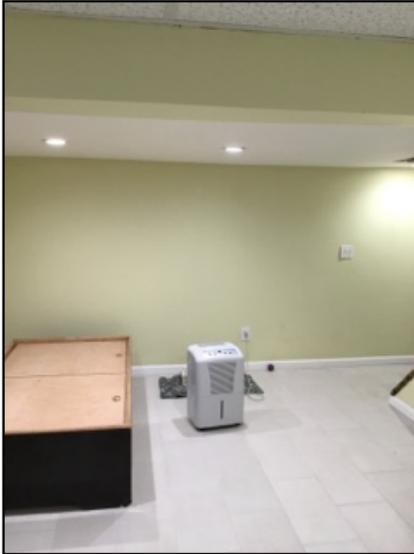
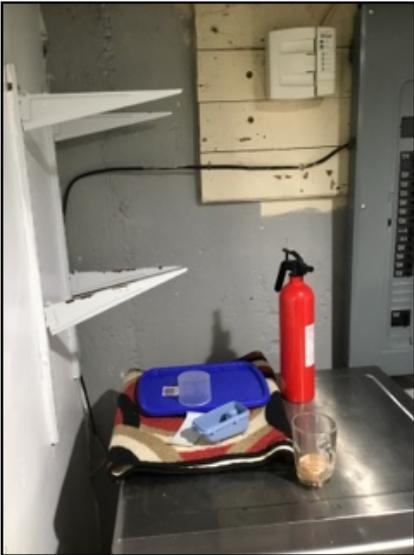
The interior of the basement appears to be in good condition as there are no active water marks or stains and the moisture content in the foundation walls are low as measured with a moisture meter. The framing and support of the house as seen from the basement are in good condition (limited visibility due to the basement being mostly finished) and to traditional building methods. No major defects were noted on the interior on the day of inspection.

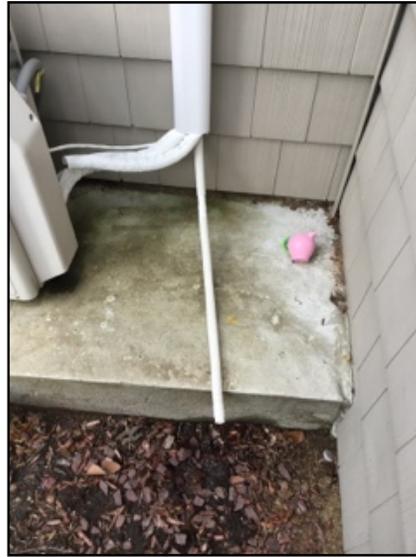
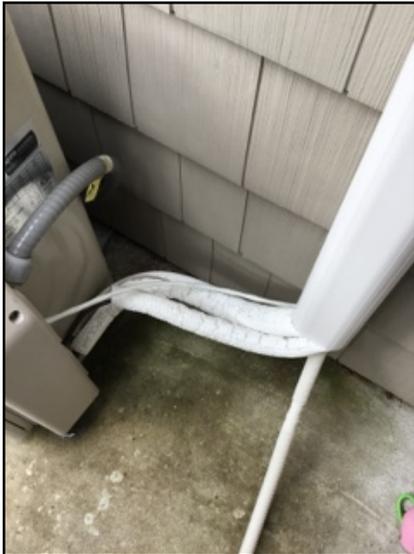
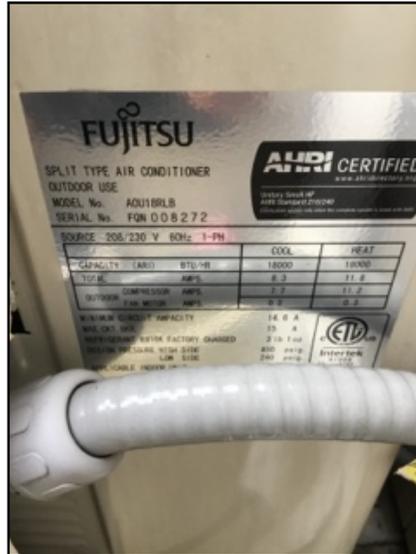
The air conditioning system was tested and operated properly on the date of inspection. No major defects were noted and it is recommended to have proper servicing done annually to ensure maximum efficiency. The refrigerant lines and electrical disconnects were noted and in good condition.

Air conditioners over 10 years old and heat pumps over 5 years old should be checked, cleaned and serviced yearly by a licensed contractor.

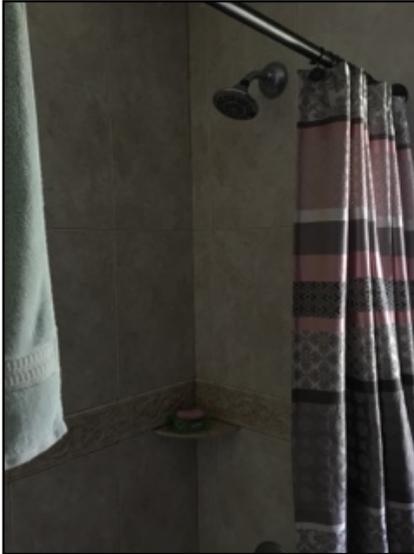
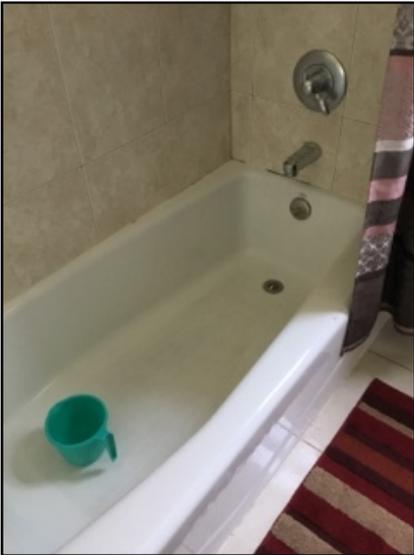
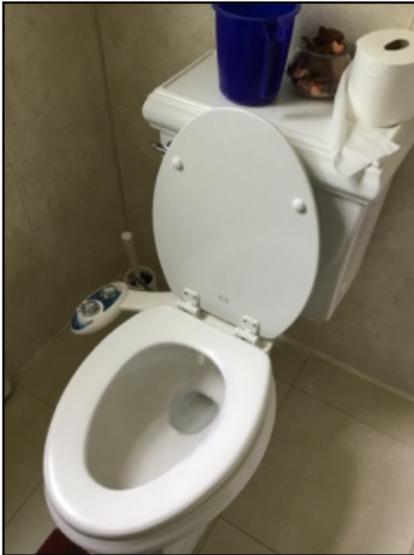
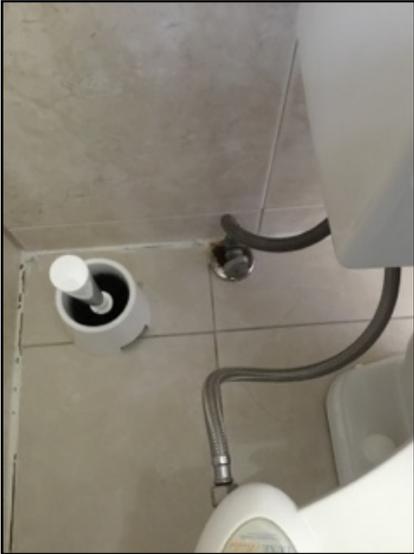
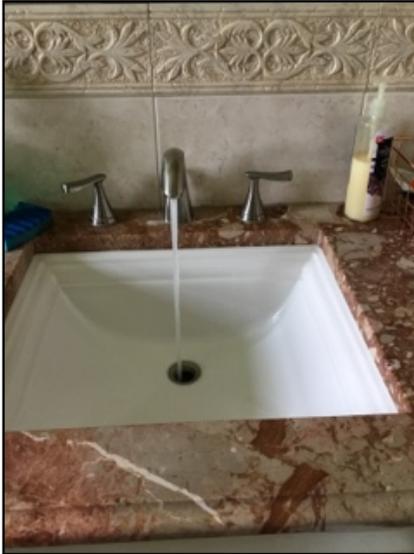
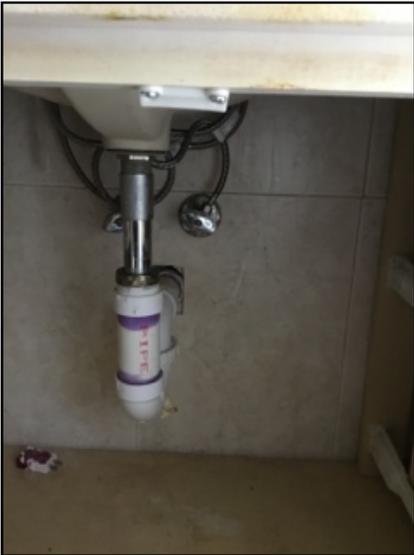
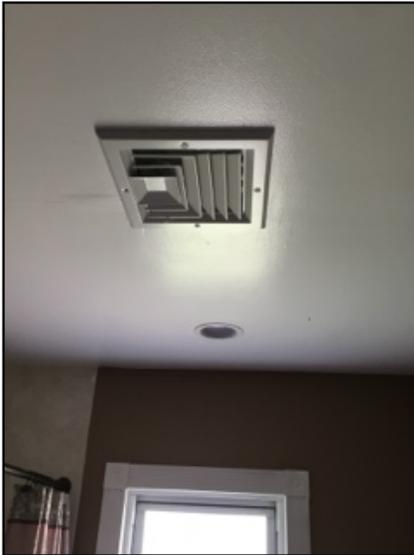
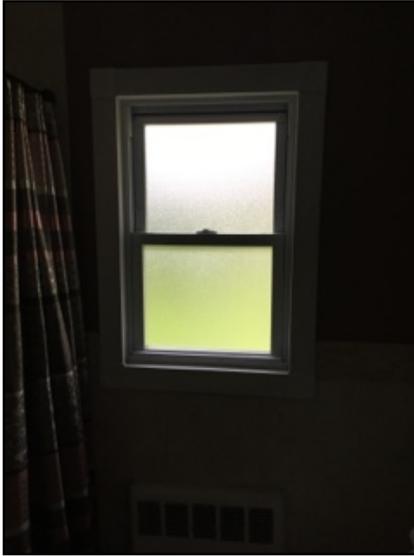
The main bath was in working condition with no leaks noted at the sink, toilet or tub/shower. There was a window and exhaust fan for ventilation and no mold or mildew was noted on the walls or ceiling.

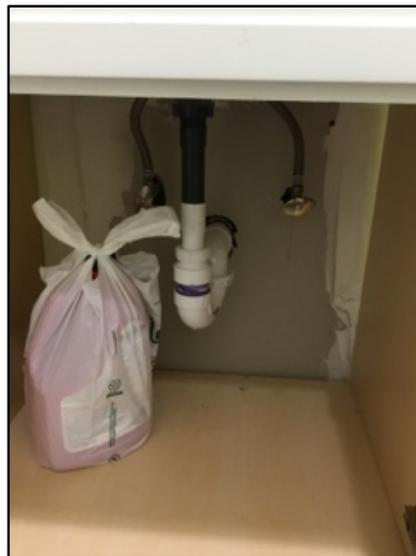
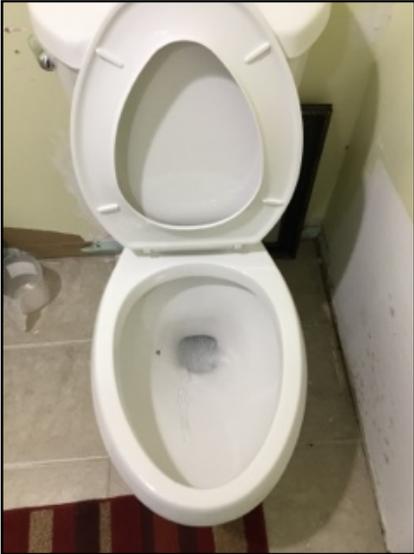
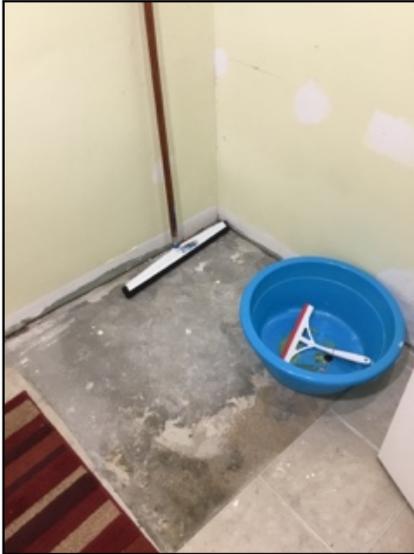
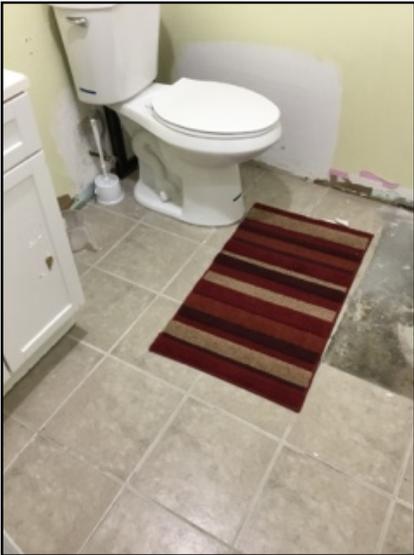
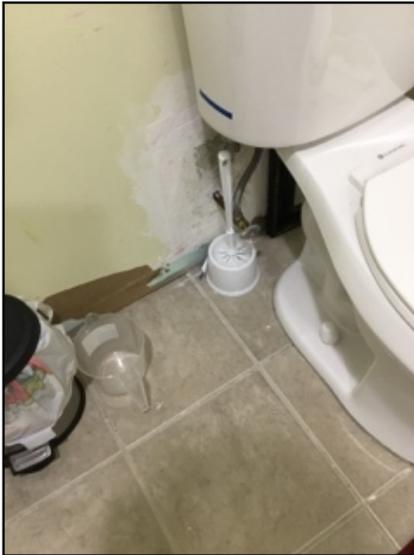
The 1/2 bath was in working condition with no leaks noted at the sink or toilet. There was an exhaust fan for ventilation and no excess moisture or mold was noted. The GFCI was tested and operated properly.

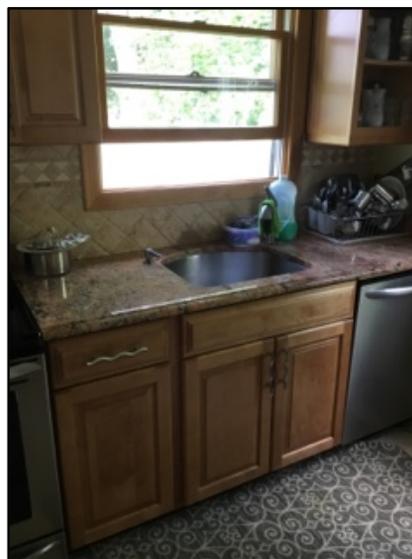
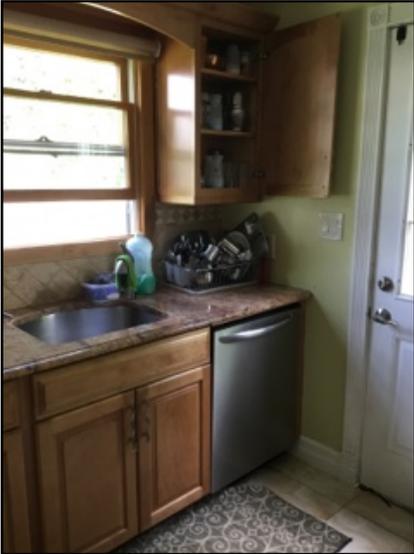
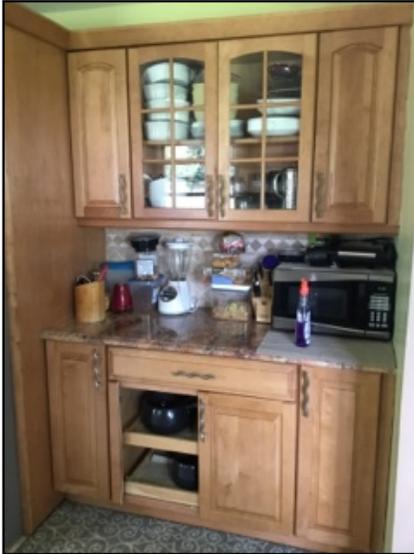
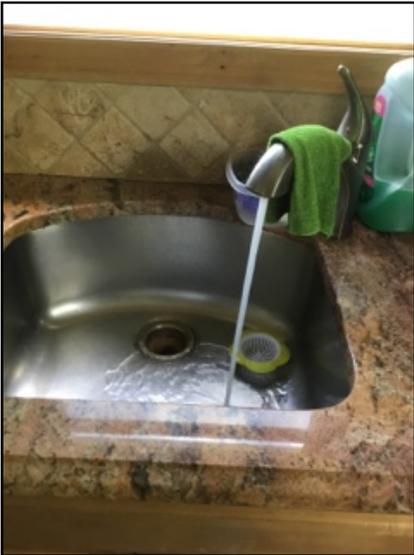
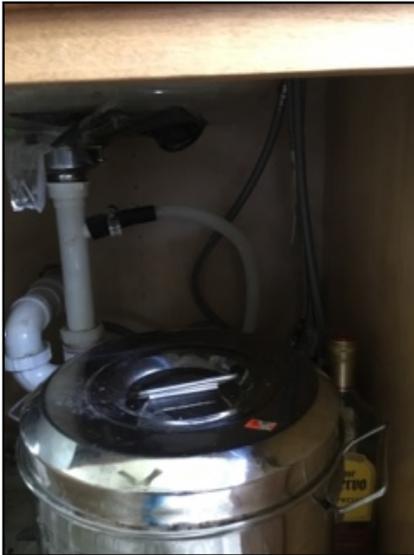
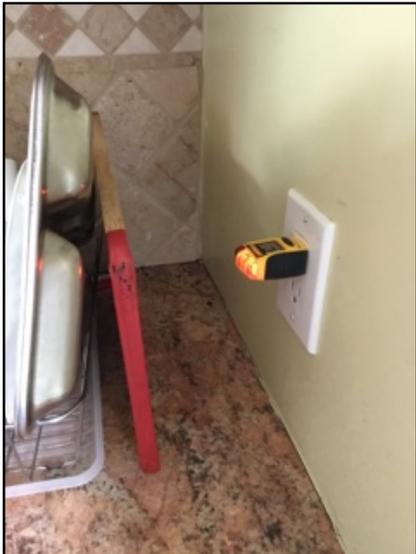
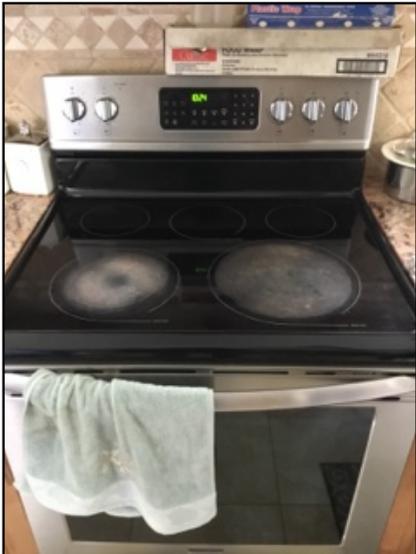
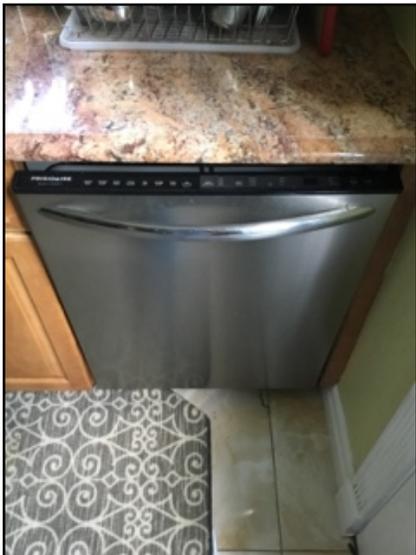
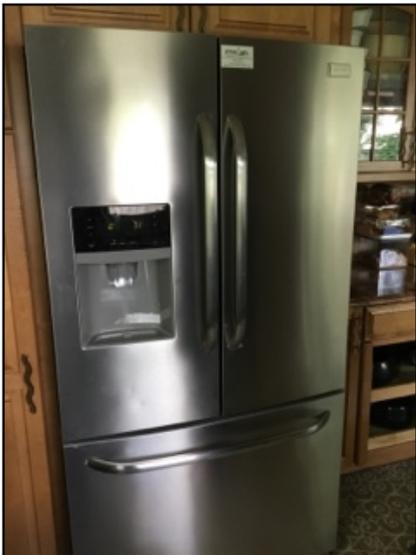
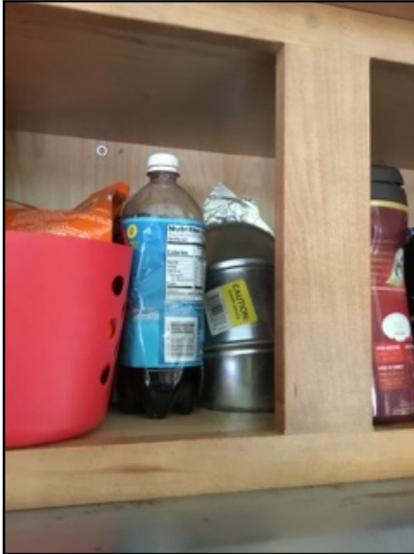
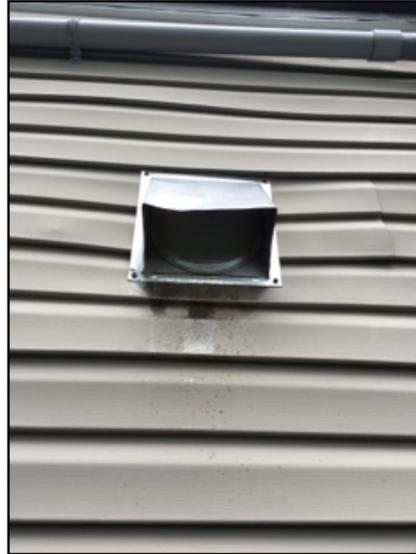
The kitchen was in working condition with no major defects noted. There were no leaks at the sink or dishwasher, and all the appliances were tested and operated properly on the date of inspection. All the cabinets and countertops were operational and secure. The exhaust fan over the stove (range hood exhaust) were tested and operated properly on the date of inspection.

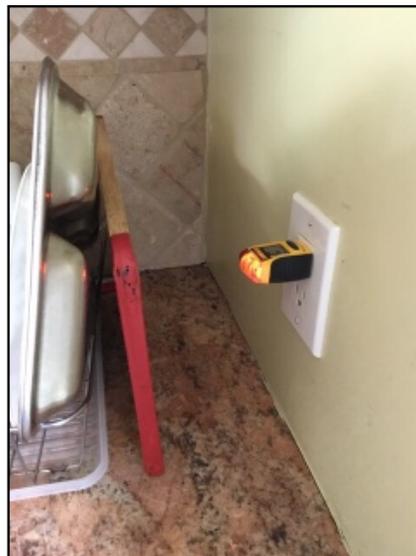
Figure 42-2

The outlets in the kitchen sink area are not GFCI and this is a safety hazard. Recommend hiring a licensed electrician to replace all outlets within 6' of the sink with GFCI outlets.

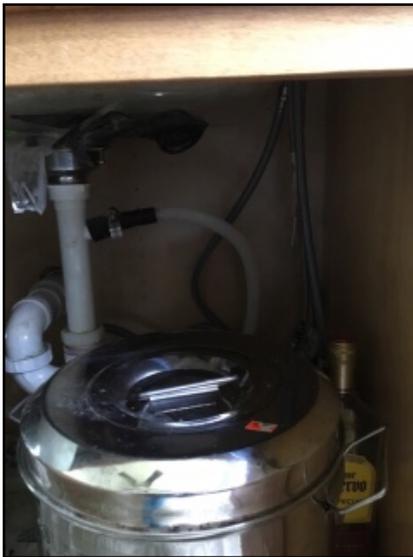
Figure 44-1

The dishwasher did not perform a loop to create a trap under sink.

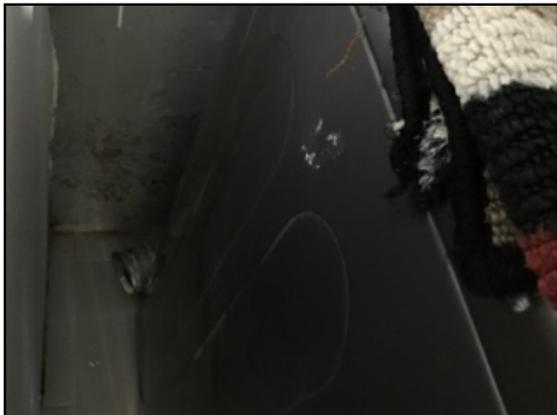
Figure 47-3

The outlet in the laundry area was not a GFCI outlet and is a safety hazard as it is directly below/next to the water supply lines. Recommend hiring a licensed electrician to replace the existing outlet with a GFCI outlet as necessary. The exhaust hose for the dryer is not connected to the dryer. The hose is also a ribbed hose you would want it to be solid metal. This is a huge fire and safety hazard. Recommend hiring a qualified contractor to install a dryer vent and to the exterior.

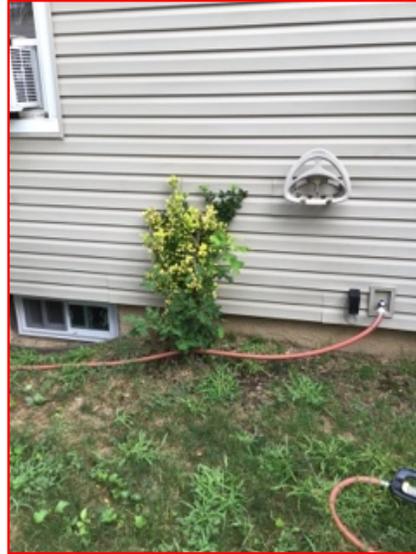
Figure 12-2

1) Shrub and tree growth are against siding. Recommend Regular maintenance and pruning should done to prevent wood rot and unwanted moisture contacting the siding of the house.

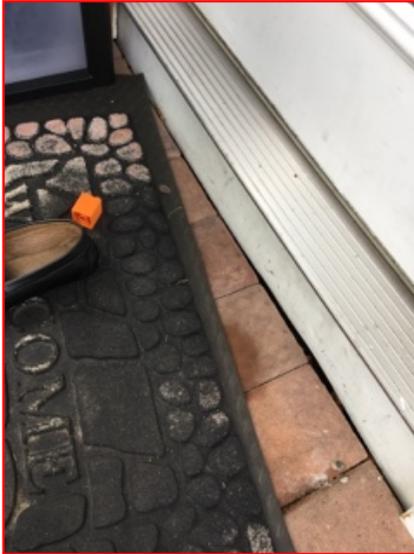
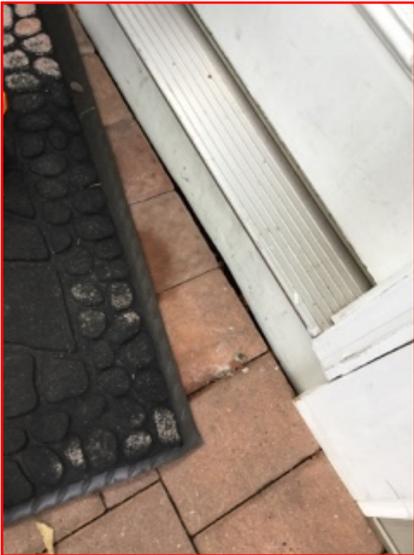
2) There is a gab between the front steps and door. Recommend closing to prevent any water intrusion.

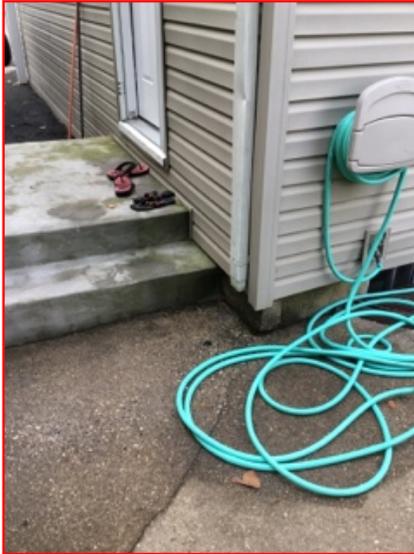
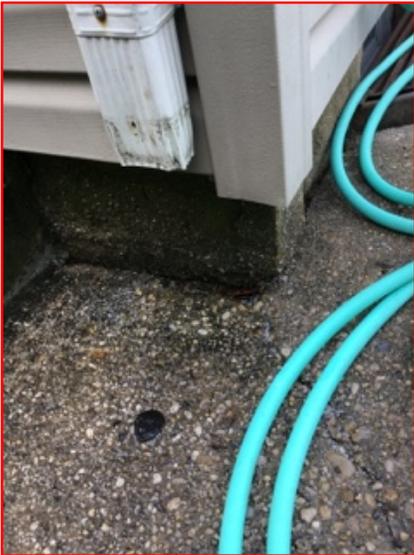
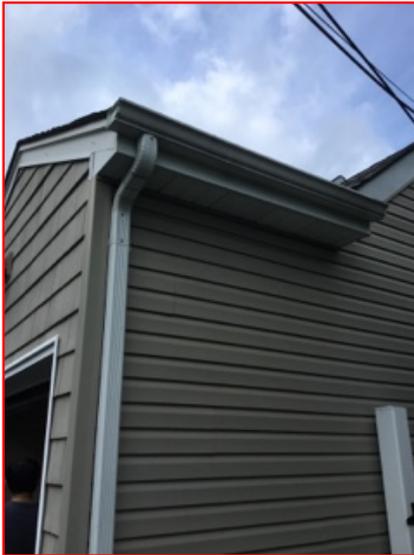
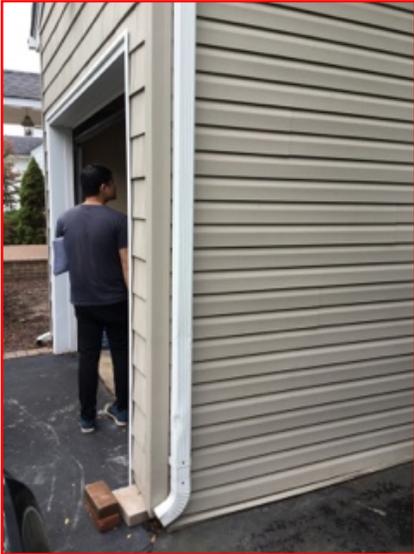
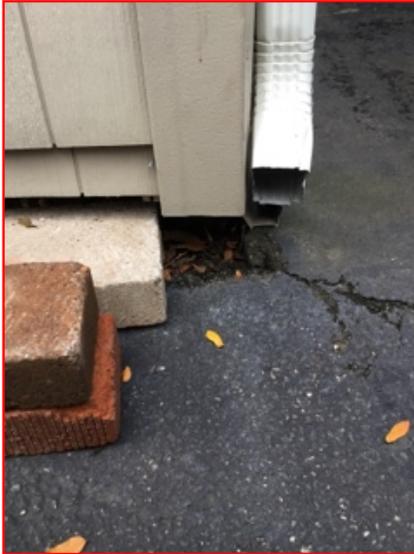
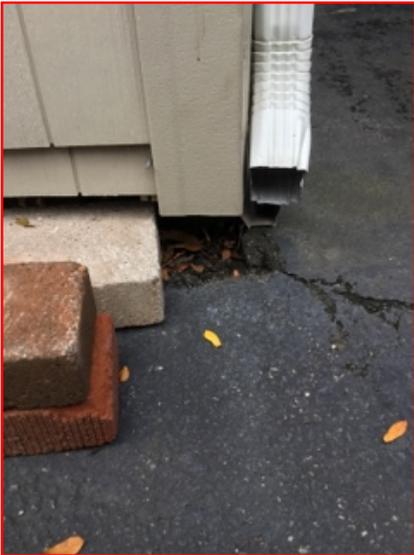
4) The gutters are aluminum and do not have proper extensions to divert rain water from the building. It appears that the gutters are functioning properly but the downspouts are not far enough away from the foundation and there are signs of moisture pooling against foundation. Recommend keeping gutters free and clear of debris as well as adding extensions to downspouts to prevent future damage to foundation.

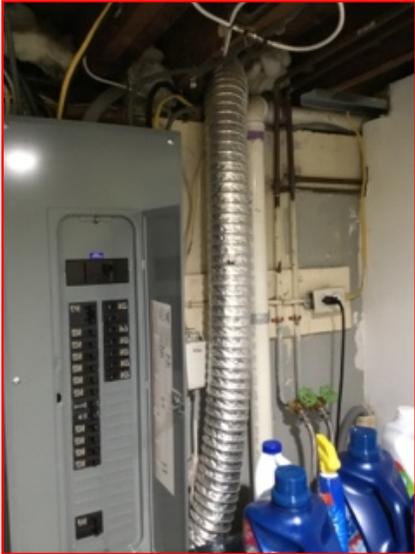
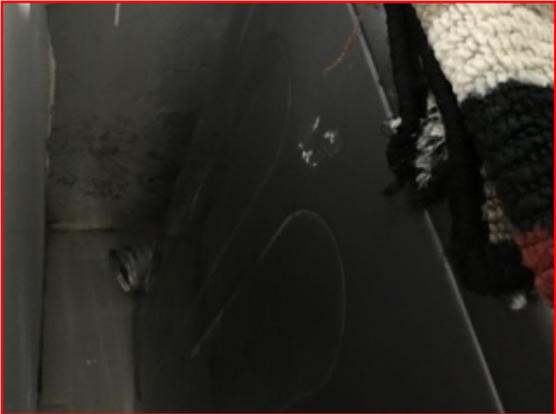
11) The outlet in the laundry area was not a GFCI outlet and is a safety hazard as it is directly below/next to the water supply lines. Recommend hiring a licensed electrician to replace the existing outlet with a GFCI outlet as necessary. The exhaust hose for the dryer is not connected to the dryer. The hose is also a ribbed hose you would want it to be solid metal. This is a huge fire and safety hazard. Recommend hiring a qualified contractor to install a dryer vent and to the exterior.
